PROJECT: ABC SCHOOL ADD/ALT
LOCATION: ANYTOWN, NY
CONTRACTOR: SCHMUCK BROTHERS CONSTRUCTION
INSPECTOR: KEN BROWN – CARINA CONSTRUCTION SERVICES

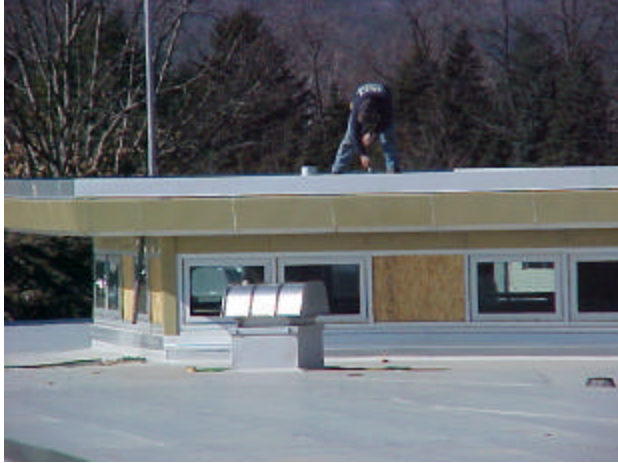
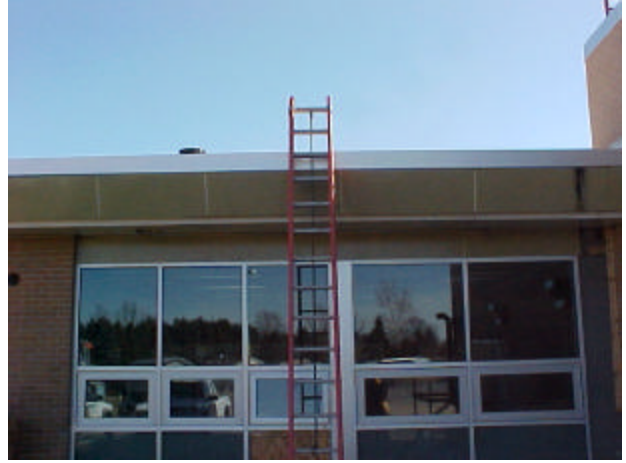
Item # 1: This roofer below gained access on to this roof by way of a stepladder. The ladder was opened but was lower than the top of the roof. The extension ladder was not extending up a minimum of 3’ and it was not tied off.

CFR Reference: 1926.1053(b)(1),(8)

Recommended Correction: Raise extension ladder 3’ above roof deck and tie off the ladder.

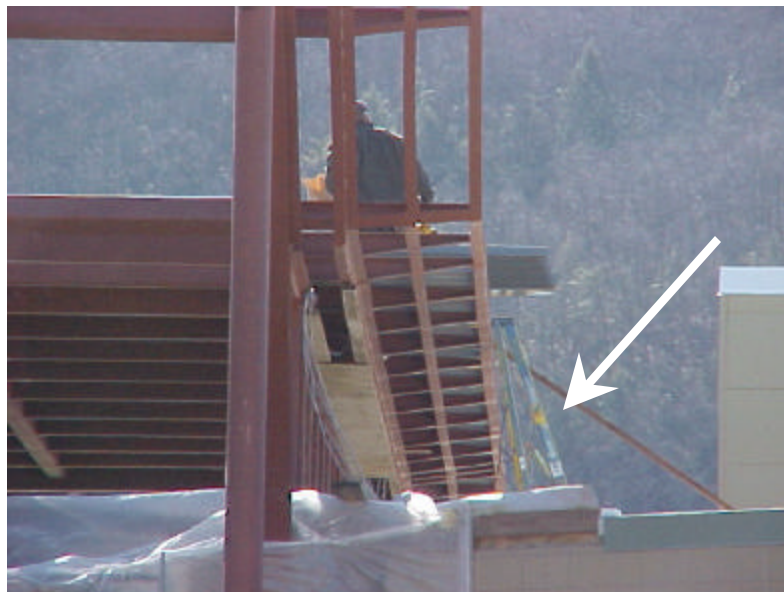
Item # 2: This ironworker below gained access to this roof by way of this stepladder. Stepladders must have the metal spreader or locking device opened when in use.

CFR Reference: 1926.1053 (a)(8)

Correction: I observed the General Contractor make a job-made ladder for the ironworkers to gain access to this section of roof.

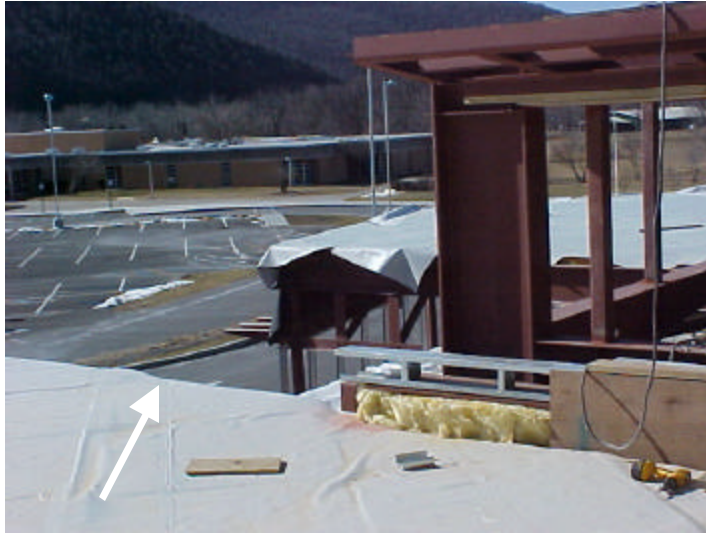
Item # 3: A warning line needs to be established in this area to keep the carpenters installing wood blocking away from this edge of the roof.

CFR Reference: 1926.502.f.1-2

Recommended Correction: Install warning line, at least 34” high, able to withstand 16 lb of horizontal force, 6’ - 8’ from edge, and flagged at 6’-0” intervals. Workers working on the leading edge will need to be tied off.

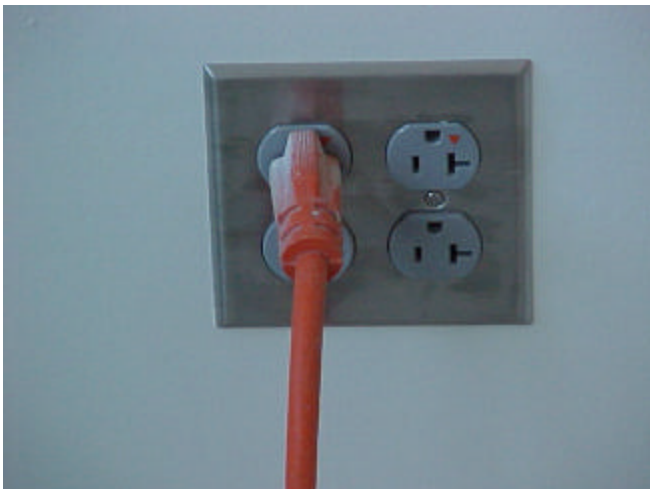
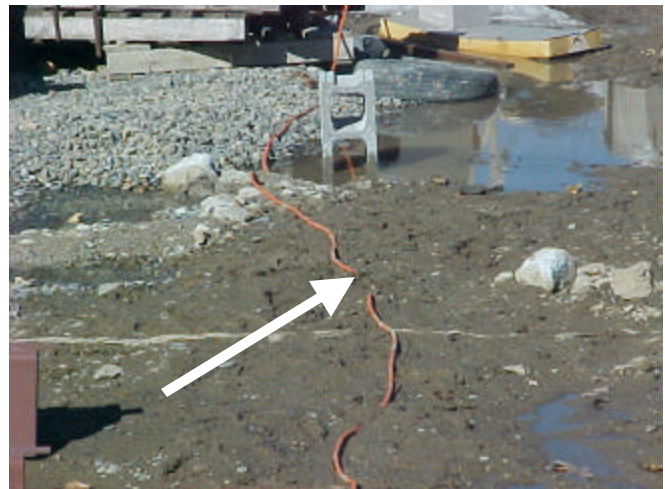
Item # 4: This extension cord needs to have a GFCI. Extension cords can not be plugged into permanent power without a GFCI device. Additionally the cord should be moved out of the water.

CFR Reference: 1926.404 (b)(1)(ii)

Recommended Correction: Use a GFCI device, or attach to temporary power equipped with GFCI protection.

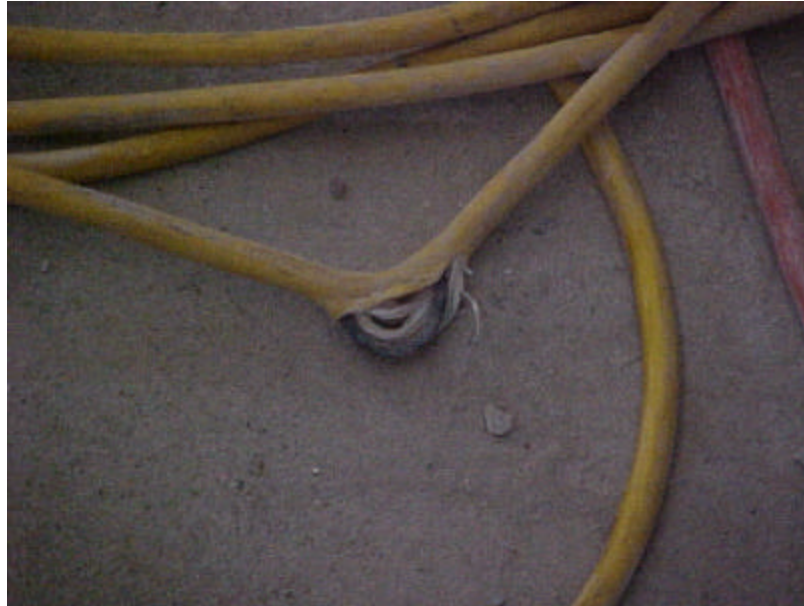
Item # 5: This damaged extension cord was being used.

CFR Reference: 1926.416.e.1

Correction: I observed the General Contractor cut the ends off the cord, take it out of service, and tag it for repair.

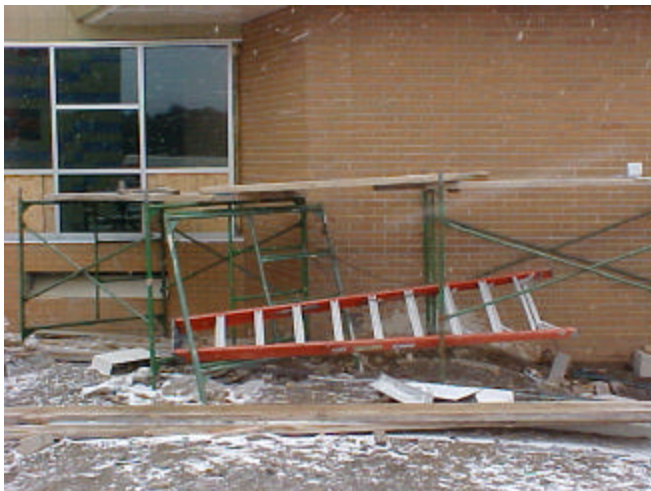
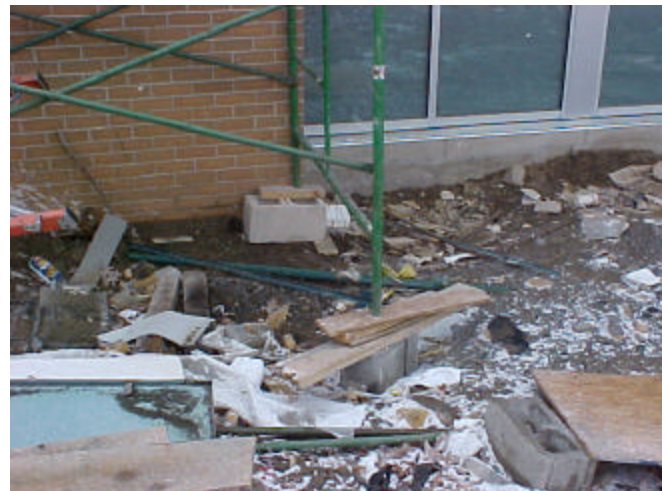
Item # 6: Scaffold platform is not level, is not fully planked, does not have base plates or mud sills installed. The work area is also extremely cluttered, presenting additional hazards.

CFR Reference: 1926.451.c.2; 1926.25.a

Recommended Action: Install scaffold level, install base plates and mud sills. Clean work area of debris and unused equipment.

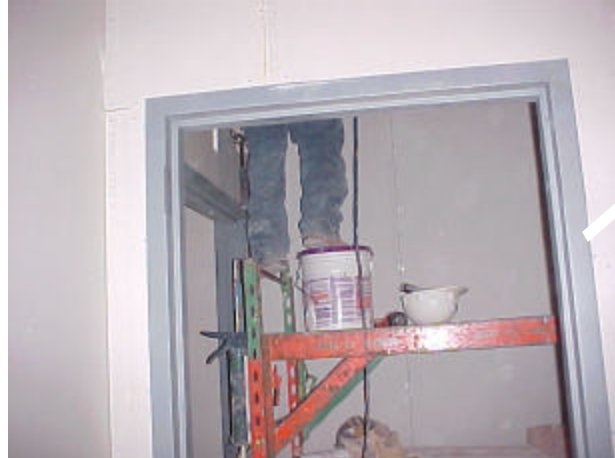
Item # 7: Worker not wearing a hard-hat. Bucket shall not be used on top of a Baker scaffold to increase the height of the platform. Can not stand on side-rail while working.

CFR Reference: 1926.451.f.14; 1926.100.a

Recommended Correction: Remove bucket from platform. Wear the hard-hat. Raise platform on Baker scaffold or get a taller scaffold.

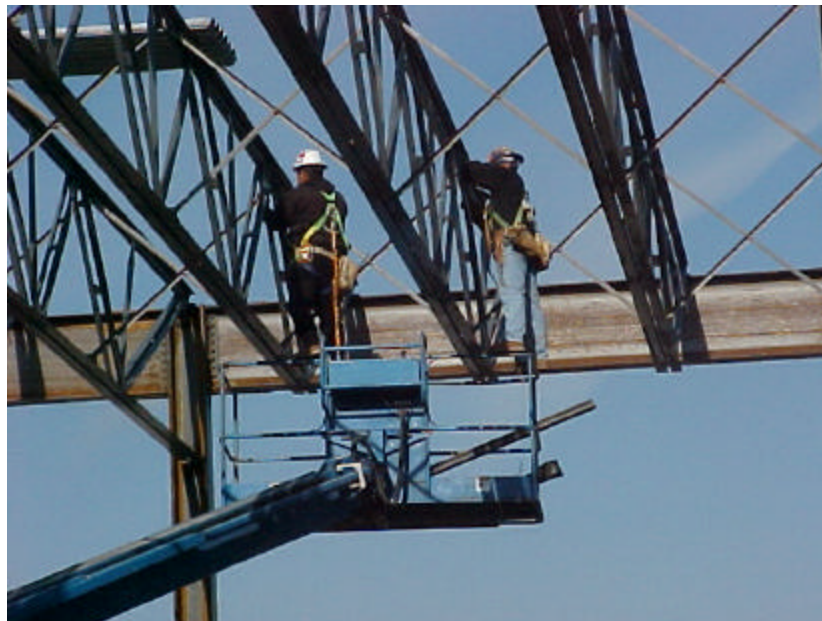
Item # 8: Workers can not stand on guardrails of lift basket. Fall protection is required as ironworkers are 15' above work surface. Worker on right needs to clip harness lanyard to the lift basket.

CFR: 1926.423.b.2.iv – v

Recommended Correction: Stay in lift basket while working. Tie off harness lanyard to the lift basket.

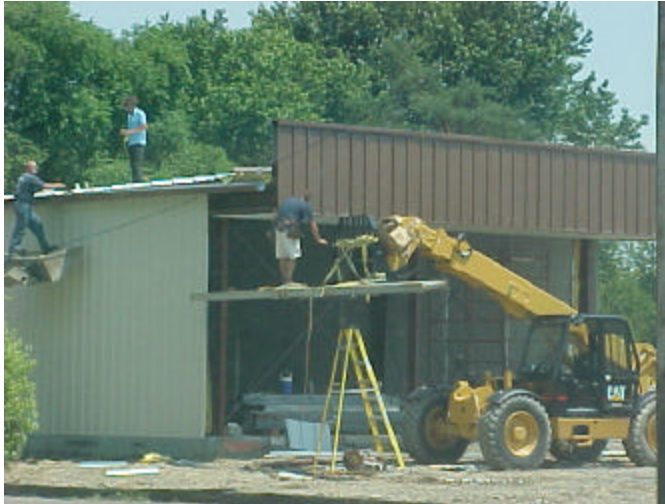
Item # 9: Workers are not wearing hard-hats, when overhead hazards are present. Working off makeshift platform, lashed to forklift forks is not allowable. Working out of excavator bucket is not allowable. Ladder access must extend 3' above a properly built working platform. An operator must be in the forklift at all times when the forklift is in use.

CFR: 1926.100.a; 1926.453.b; General Duty Clause; 1926.1053.b.1

Recommended Correction: Wear hard-hats. Use a proper all terrain basket lift. Working out of buckets or on make shift platforms is **never** allowable. Provide ladder access to roof or scaffolding, with top of ladder extending 3' above work surface.

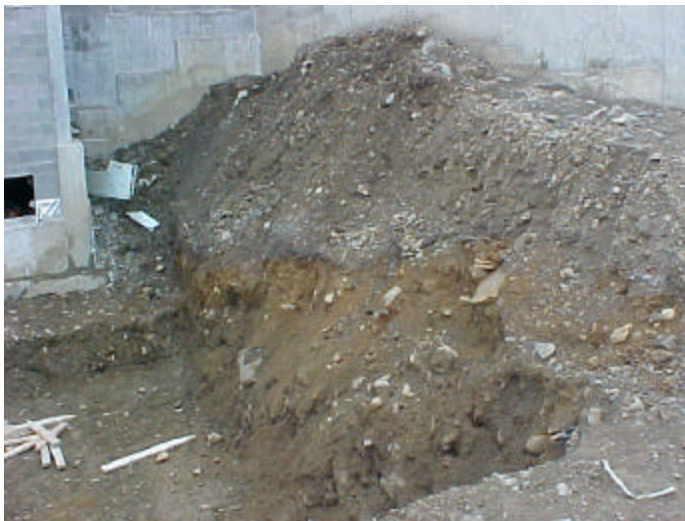
Item # 10: Spoil pile must be 2' back from edge of bottom of excavation area. Additionally sides of excavation are not properly benched or sloped.

CFR Reference: 1926.651.j.2

Recommended Correction: Move spoil pile. Excavate earth to level no greater than 5' above bottom of work area. Alternate method: Install sheilding or sheet piling to protect excavated area.
